Manhole Inspection Summary

Manhole # S51K__051MH

Location Address: **2935 Fait ave**

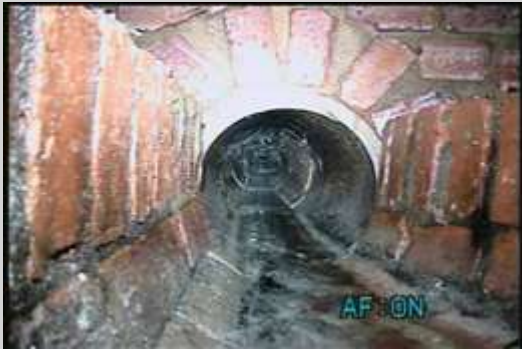
12 O'Clock Outflow

8 in. Circular Gravity Sewer
Pipe Out @ 12 O'Clock

Pipe Height: 0 (in.) Direct

Pipe Material: **Clay** ☐ Pipe Lined

Infiltration: **None** Pipe Seal Cond: **Unknown**
